Manhole Inspection Summary

Manhole # S43M__013MH

Insp Date: **3/9/09 9:03 AM**

Location Address: **1601 SHAKESPEARE ST**

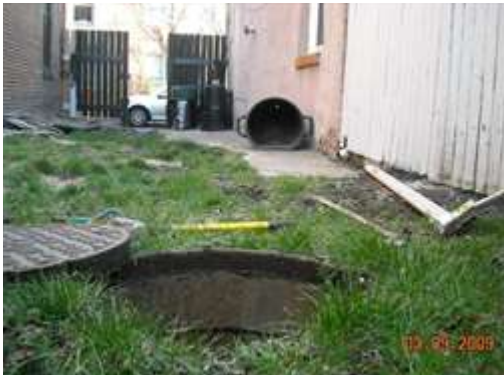
Location View

Comments **ON PRIVATE PROPERTY BEHIND FENCE, MADE CONTACT WITH PROPERTY OWNER TO GAIN ACCESS; USED 16LB MAUL AND SPRAY LUBRICANT TO FORCE OPEN MANHOLE COVER.**

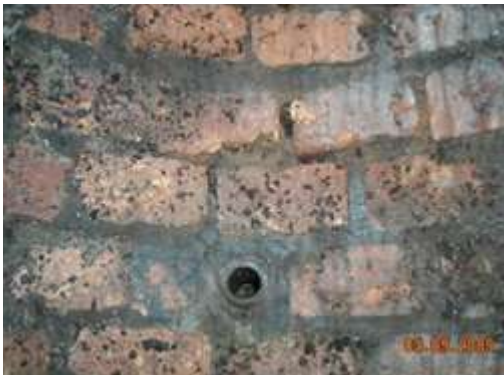
MISC.

PIPE INTRUSION OF CORBEL WALL @
12 OCLOCK

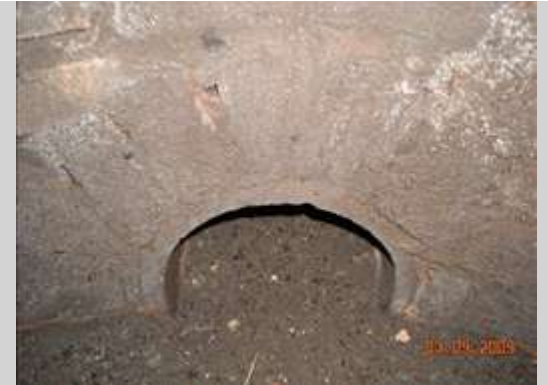
12 O'Clock Outflow

8 in. Circular Gravity Sewer
Pipe Out @ 12 O'Clock

Deposits: ☐ None ☒ **Mud** ☐ Sludge ☐ Debris ☐ Grease

Silt Depth: **1** (in.) Deposits Extent: **Light**
